Injury Risk Eliminated With Gorbels® Free Standing Work Station Cranes

Industry:
Power and Electric

Product:
Testing of Lift Baskets

The Solution:
Gorbels® Free Standing Work Station Cranes

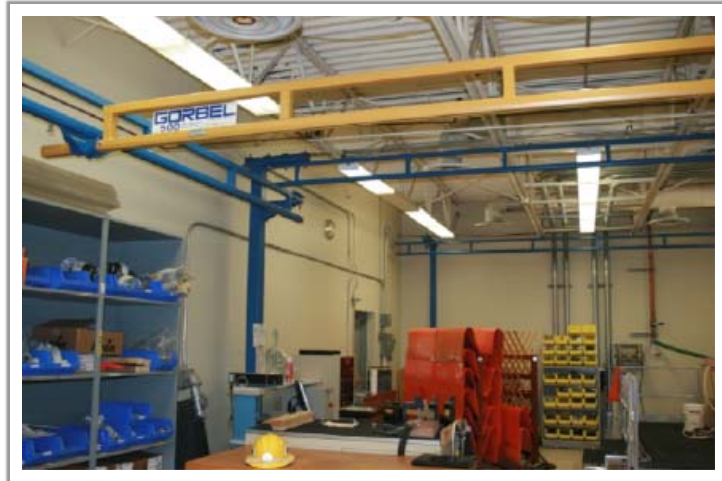
One person can easily do now what it took two or three people to do previously

The company selected a Gorbelt 500 pound capacity work station crane to cover the entire work area. However, in order to service the entire work space, the system was installed as two perpendicular systems that shared common support columns.

“What we faced was that in order to clear an overhead door on one side, we were limited for our overall height. On that side, the floor to trolley clevis distance is about 8 feet 6 inches,” said the dealer salesperson. “However, if it was that low throughout the workspace, we couldn’t get the lift required to get the baskets out of the tub. So at that end of the room, on the perpendicular system, the floor to trolley clevis height is 10 feet 2 inches.”
